Building Inspection Report

in accordance with AS4349.1

Date of Inspection: Wednesday, 10 February, 2021

Property: 33 Disraeli Road, Winston Hills

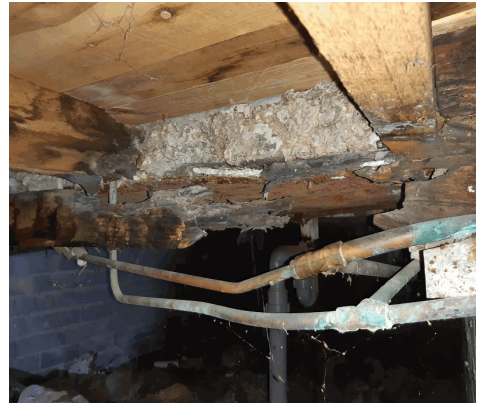
Floor Frame

Timber members adjacent to the bathroom have significant decay and there is a high probability of further concealed decay. All decayed timber members should be removed and replaced to provide structural adequacy.

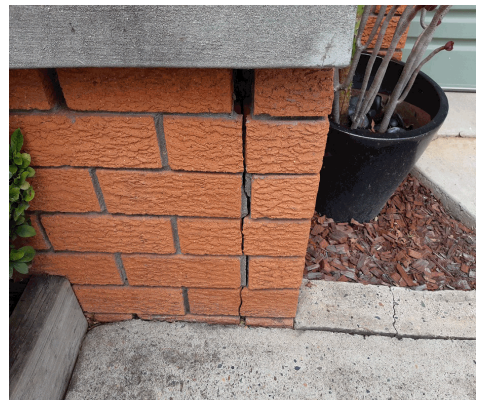
Brickwork

Settlement cracking is evident to the brickwork and this should be kept under observation for signs of further deterioration.

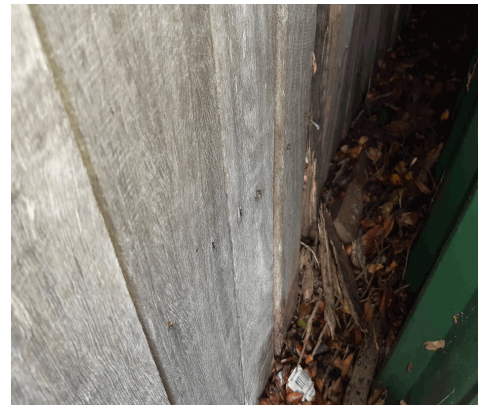
Fencing

Some sections of the timber fencing are termite damaged, decayed or out of alignment and require repairs/replacement to obtain a satisfactory finish. A complete pest inspection is recommended to this property by a registered pest inspector to ascertain the activity or presence of termites and advise on a treatment proposal.
