Building Inspection Report

BUILDING INSPECTION REPORT

Report Number: 36913326

Property: 39 Coora Road, Westleigh

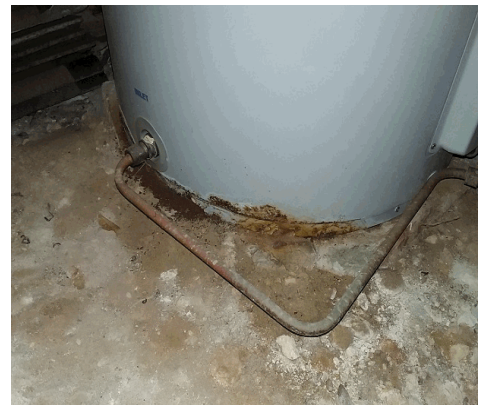
Hot Water Unit

The hot water unit has evidence of corrosion and requires repairs/replacement to prevent further deterioration.

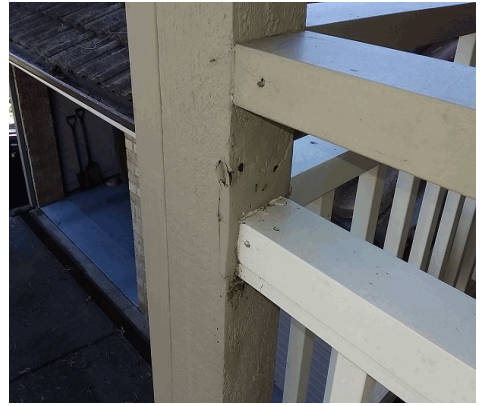
Front Verandah

Decay is evident to several handrail timbers and repairs/replacements in the near future will be necessary to prevent further deterioration.

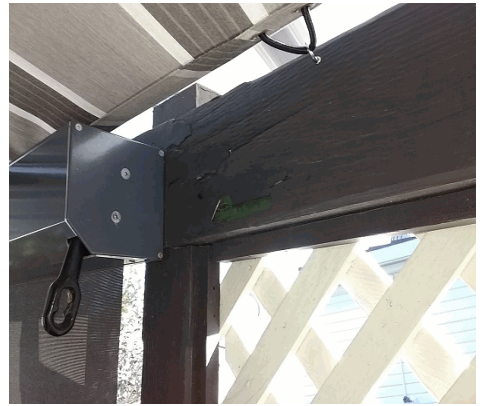
Rear Pergola

Decay is evident to several exposed timbers and repairs/replacements in the near future will be necessary to prevent further deterioration.

Gutters/downpipes are also required to this area to allow the correct dispersal of rainwater into the stormwater lines.

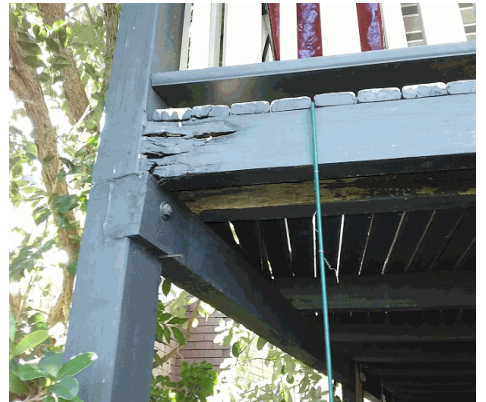
Rear Timber Deck

Decay and deflection is evident to several exposed timbers and repairs/replacements in the near future will be necessary to prevent further deterioration.

Parts of the handrail to this area is also loose and rectification/repairs are required for safety reasons.

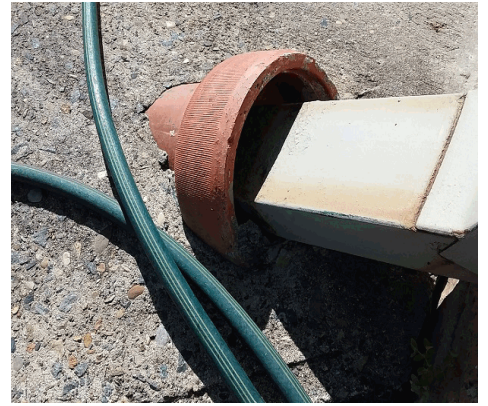
Downpipes

Several downpipes are not adequately sealed to the stormwater connections. Repairs/re-pointing with a cement mortar is required to provide a satisfactory finish.

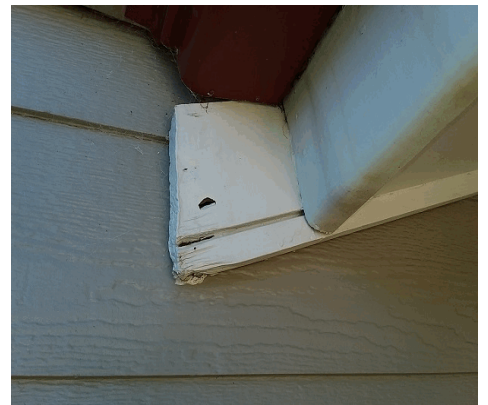
Fascias/Barges

The fascias/barges have evidence of decay and some sections require repairs/replacement to obtain a satisfactory finish.

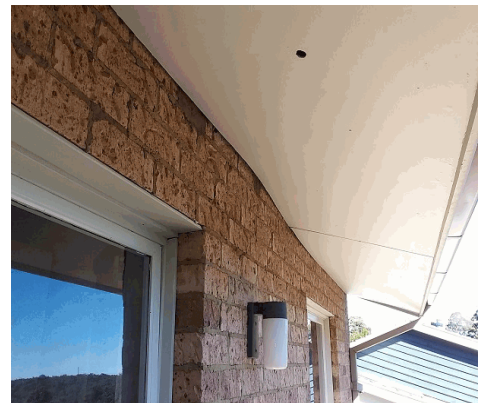
Eaves

The loose and sagging sheets require repairing or refixing to provide a satisfactory finish to the eave linings.
